**NASA TM X-71734**

**HOT CORROSION EVALUATION OF ALUMINIDE COATED SUPERALLOYS  
IN SUPPORT OF AN ASTM ROUND ROBIN PROGRAM**

by Gilbert Santoro  
Lewis Research Center  
Cleveland, Ohio 44135  
July, 1975

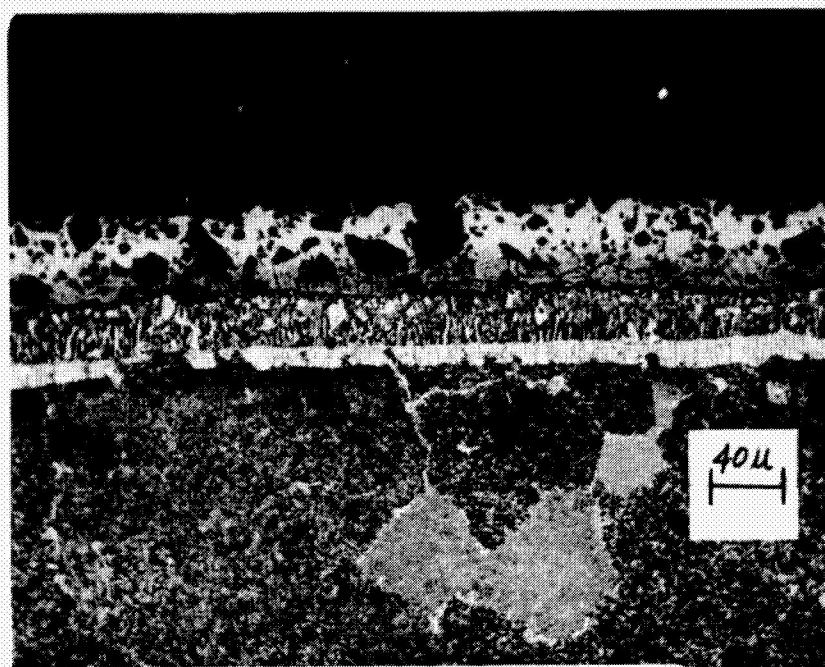
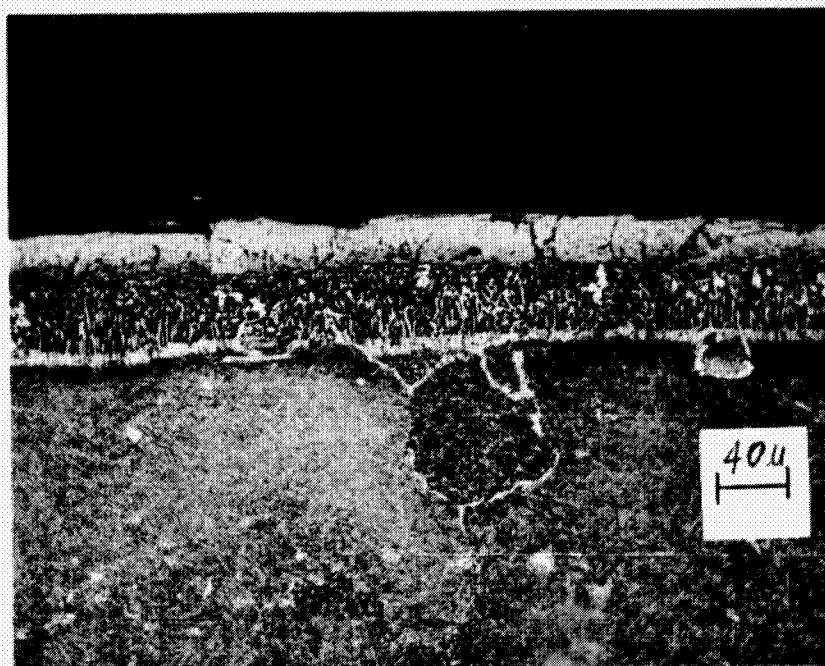
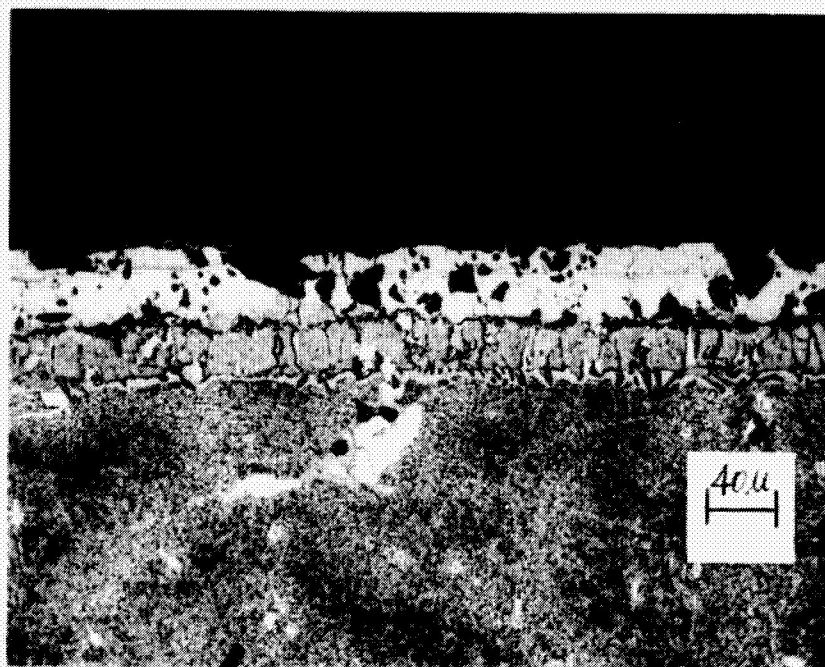
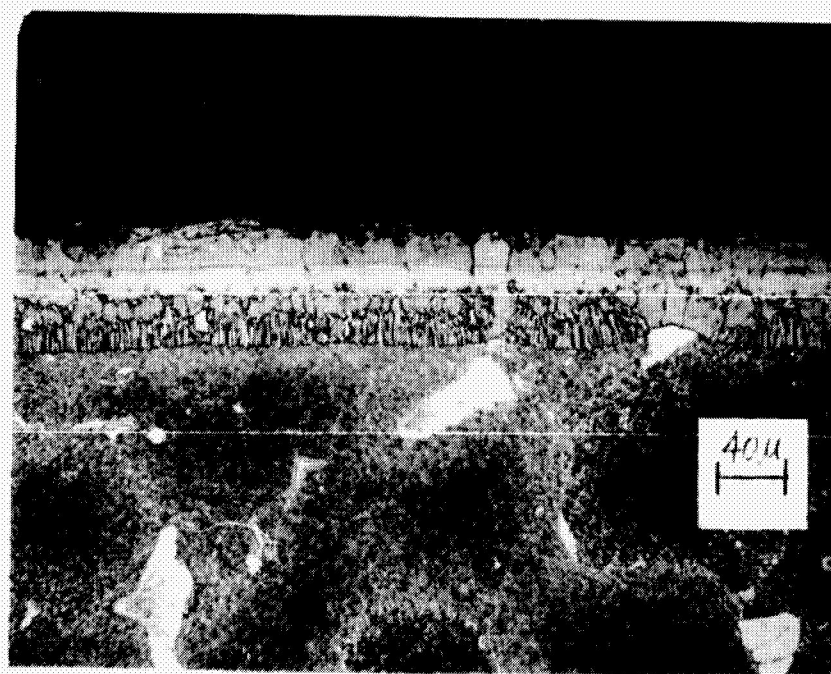
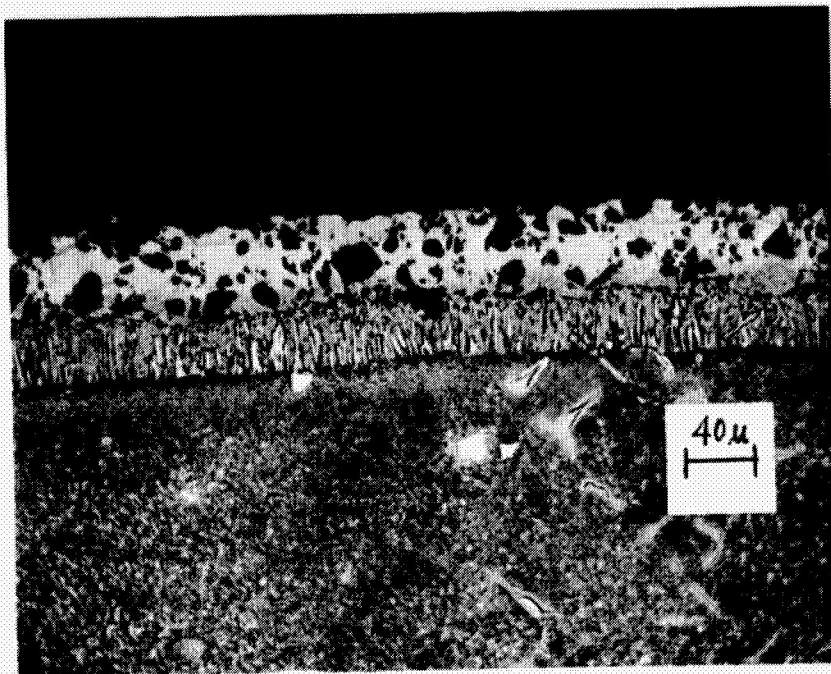
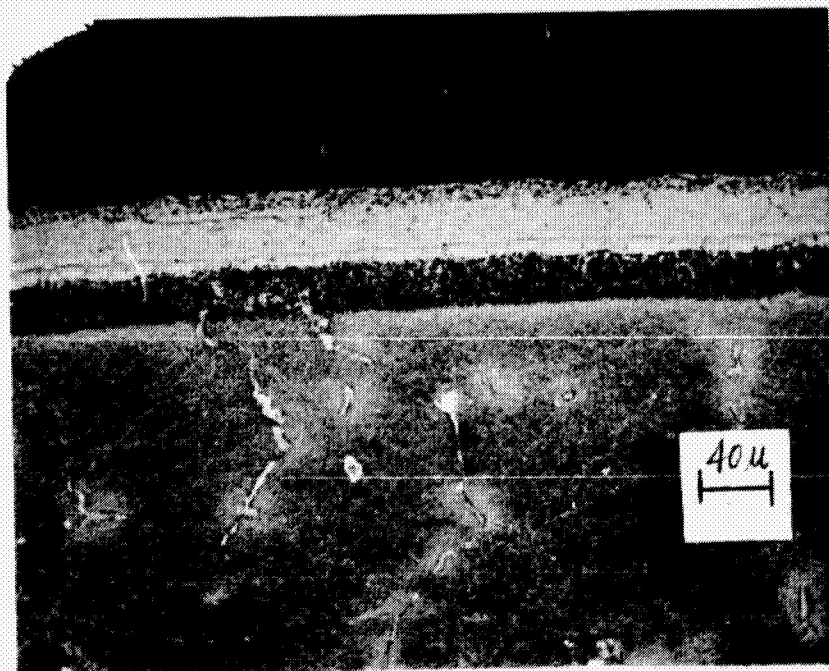
$\beta$ NiAl (beta nickel aluminide). In most cases weak lines of alpha alumina,  $\alpha$ Al<sub>2</sub>O<sub>3</sub>, were also observed, see Table II. Figure 1, (a) through (f), shows the microstructure of the as-received coatings and their substrates. Both coatings have complex microstructures with the structure of the diffusion zone dependent upon the substrate. With the B-coatings even the structure of the coating proper seems somewhat dependent on the substrate. Elemental analysis by the scanning electron microscope's energy dispersive x-ray spectrum shows that the dark particles in coating A to be predominately (aluminum) Al, probably  $\alpha$ Al<sub>2</sub>O<sub>3</sub>, in correlation with the XRD results. In both coatings (A and B) the elemental distribution is qualitatively the same. As an example of this distribution the details for coating A on IN-713C will be given. In the coating proper, figure 2(a), the intensity of the (nickel), Ni, peak predominates. The (chromium), Cr, and the Al peaks are about the same height, about 1/5th that of the Ni peak. There is also a slight indication of a (titanium), Ti, peak. The Cr intensity increases slightly near the diffusion zone, figure 2(b). In the diffusion zone just below the coating proper the Ni and Cr peaks have about the same height, figure 2(c). There are also a small (molybdenum), Mo, peak a slight Al peak and an indication of a Ti peak. In the diffusion zone near the substrate, figure 2(d), the Ni peak again predominates, the Cr peak has decreased and the Mo and Al peaks have remained about the same. There is here a measurable Ti peak. In the substrate near its interface with the diffusion zone, the relative peak heights

Figure 1. - Microstructure of the as-received coatings showing the coating proper, the diffusion zone and the substrate.

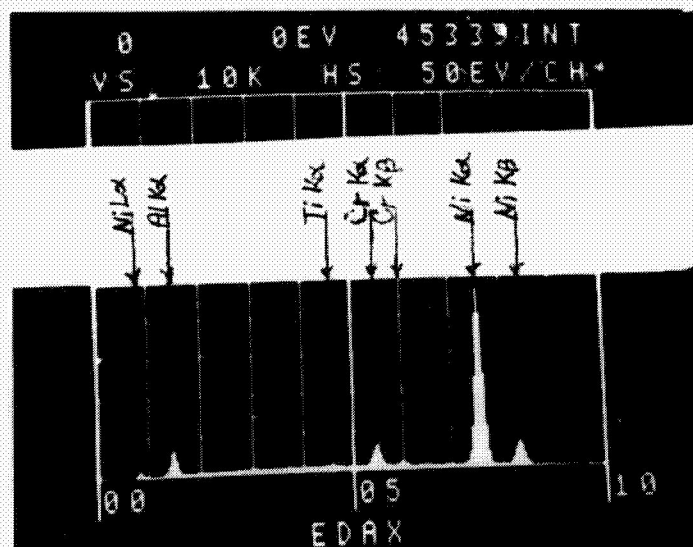
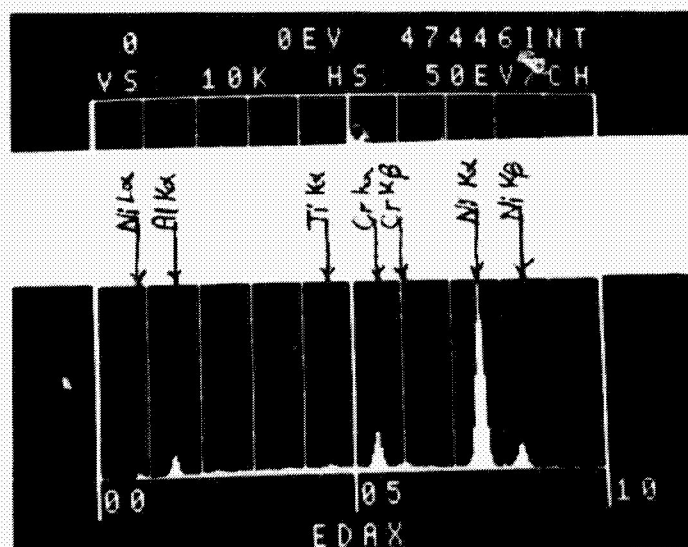
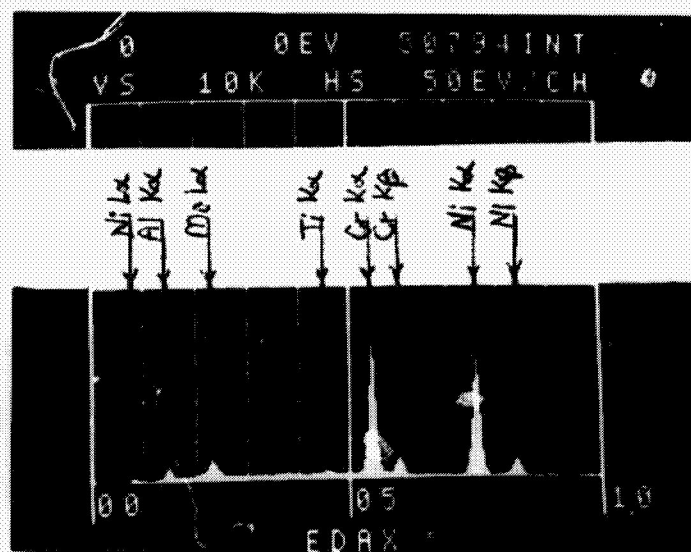
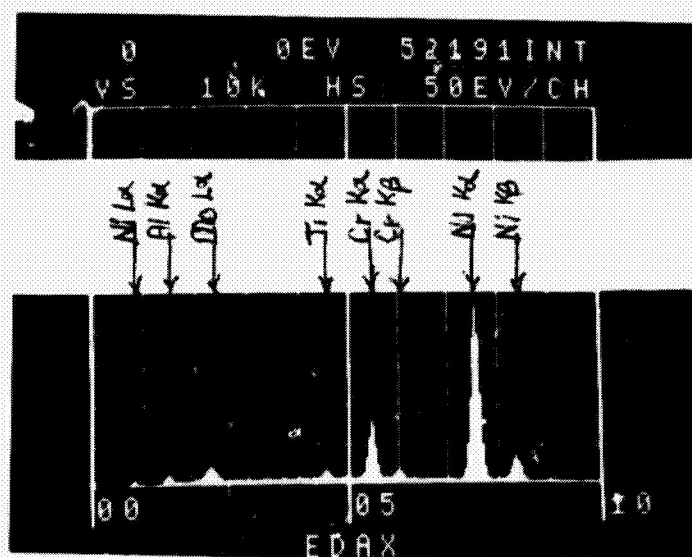
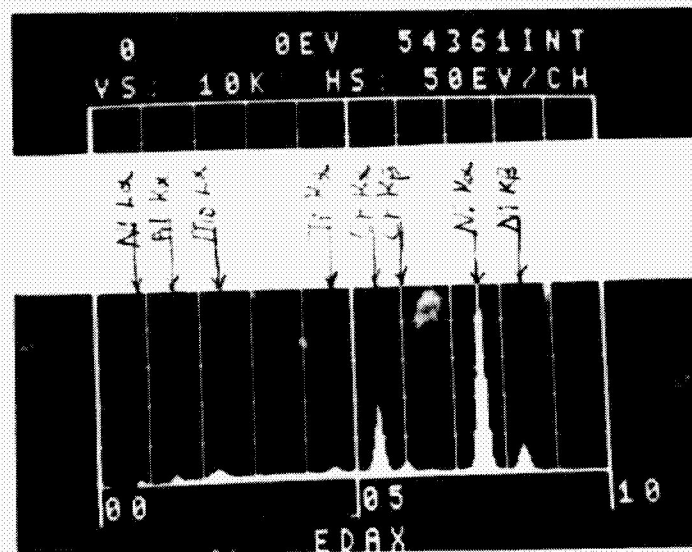
are Ni>>Cr>>Mo>Al>Ti, figure 2(e).

Figure 2. - Energy dispersive spectrum for elements in coating A on Ti-713C, as-received.

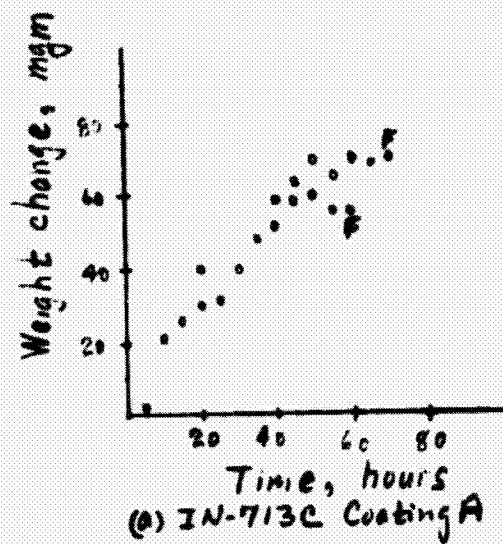
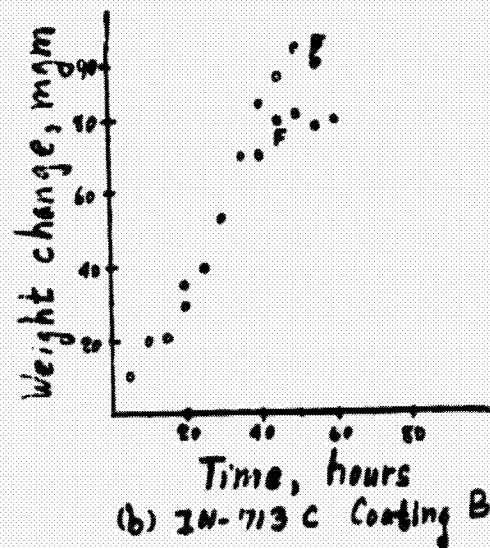
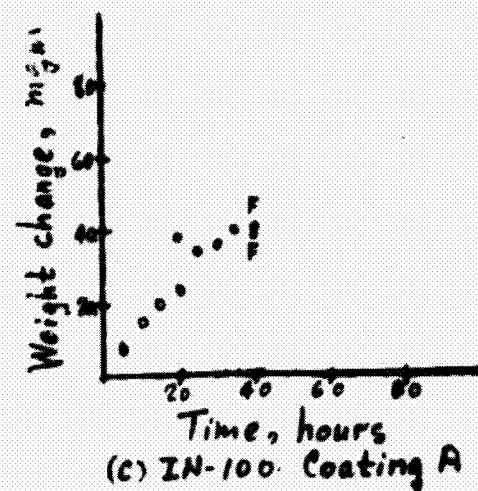
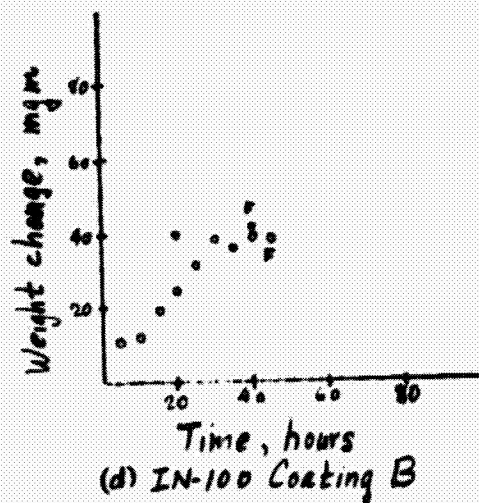
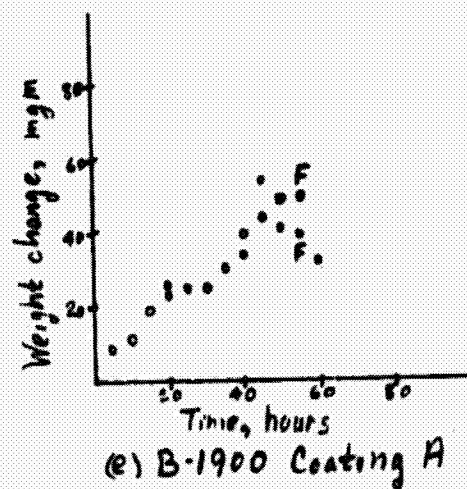
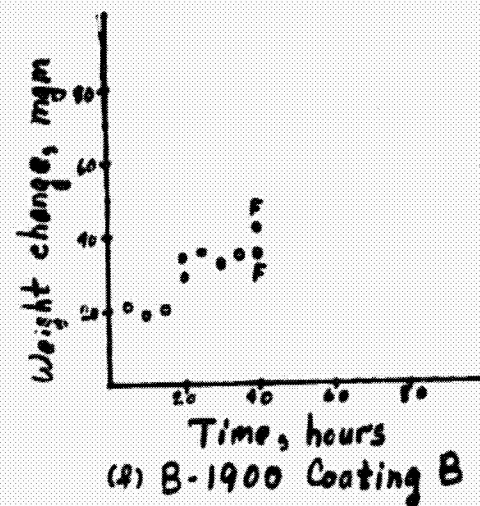
Weight change results are given in figure 3, (a) through (f), for the 10 minute cycle runs and in figure 4, (a) through (c), for the one hour cycle runs. The data points where coating failures were first observed are marked with "F". Most often coating failure was preceded by a decrease in the slope of the weight change curve, indicating the on-set of spalling. It was observed that the spalling was not restricted to the oxide scale. The coating also spalled. Usually the coating began to spall shortly before coating failure, i.e., the time when the slope of the weight change curves decreased. For example, with coating B on IN-100 no spalling of the coating was observed up to 30 hours at temperature, figure 5(a). After 30 hours the slope of the weight change curve decreased, figure 3(d). After 45 hours the coating failed. A pit was observed in one of the areas vacated by the spalled coating, figure 5(b). Failure pits were often found in areas where the coating had spalled. A magnified view of a pit in such an area is shown in figure 5(c). Thus spalling of the coating is a factor in coating failure.

Figure 2. - Weight change of coated alloys at 900°C and ten minutes cycles.  
Failure occurred at points marked "F".

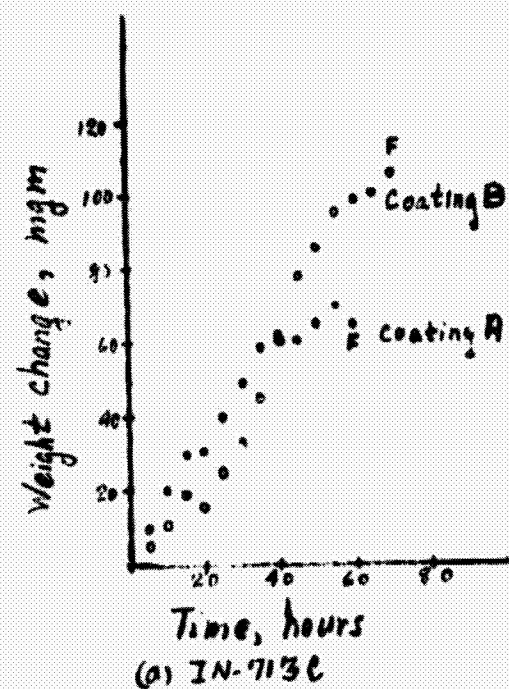
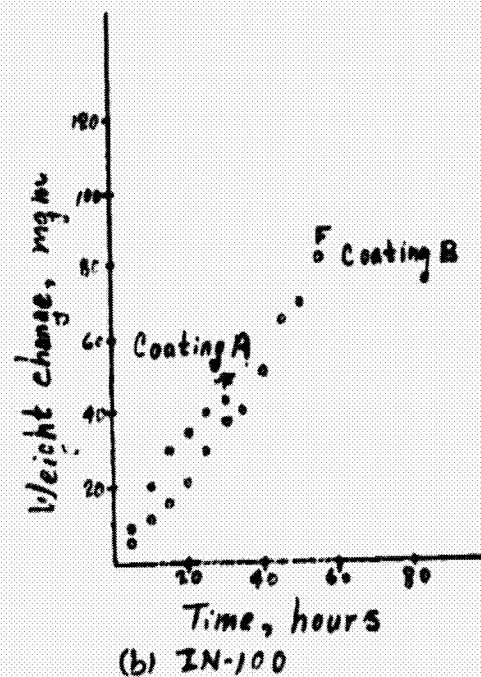
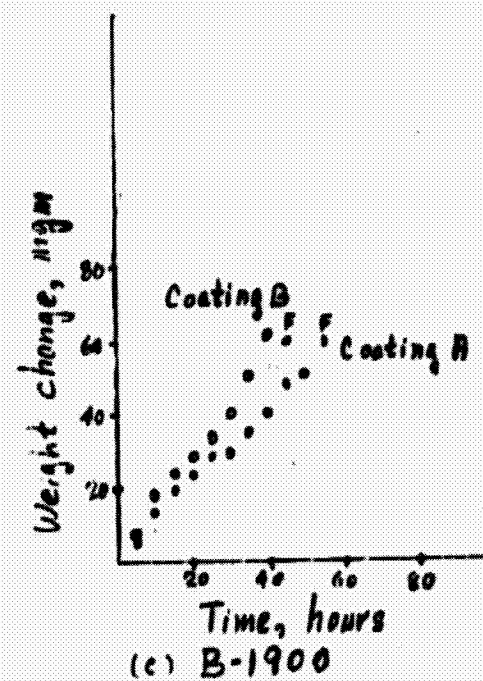
4  
 Figure 4 - Weight change of coated alloys at 900°C and one hour cycles.  
 Failure occurred at points marked "F".
